# INTRODUCTION

PRESERVATION GUIDE FOR  
STONE MASONRY  
AND DRY-LAID RESOURCES

ABBY GLANVILLE  
GREG HARTELL INTERN  
FOR HISTORIC PRESERVATION  
SUMMER 2008

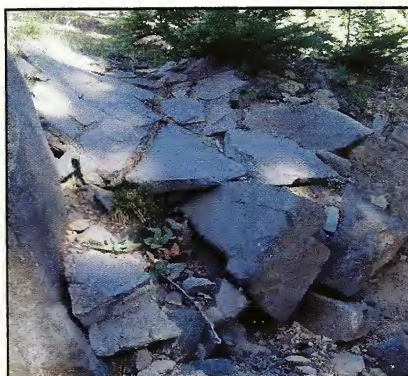
Deterioration of a tiled masonry drain across from the Sun Notch parking lot at mile 4.4

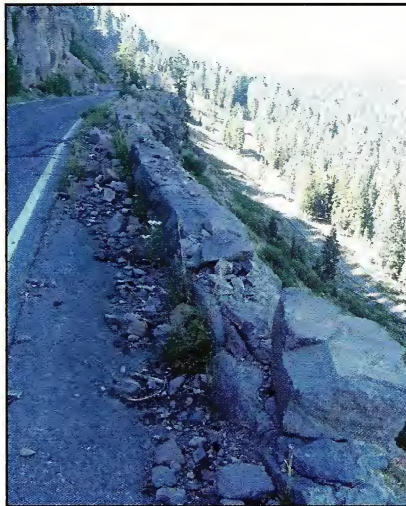
Massive deterioration of guard wall along Dutton Cliff at mile 7.5-8.0

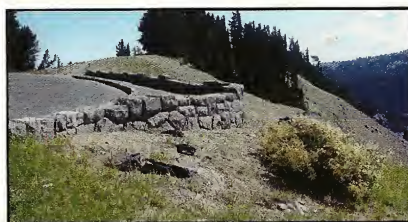
The guard wall at the Sentinel Point Turnout at mile 10.7 demonstrates appropriate distribution of stone size and variation of stone color.

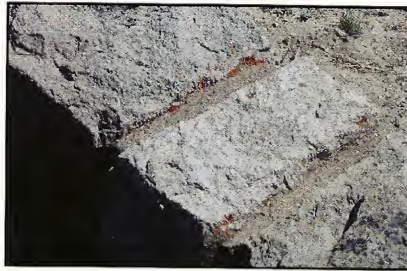
ticularly important at Crater Lake due to the variation in temperature and average yearly snow and rain fall. The components of historic mortar at Crater Lake are sand, lime, cement, water, and pigment. It is believed that builders may have used pumice from the surrounding terrain to give the mortar its red color.

The guard wall at the turnout at mile 10.5 shows the red tint found in historic mortar.

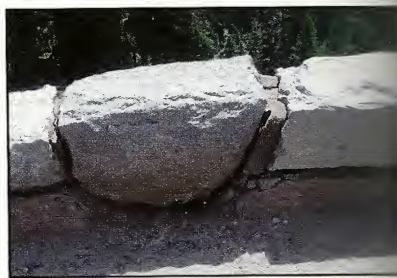
Guard wall at mile 4.5-5.0 on Sun Grade showing a loose stone caused by mortar deterioration.

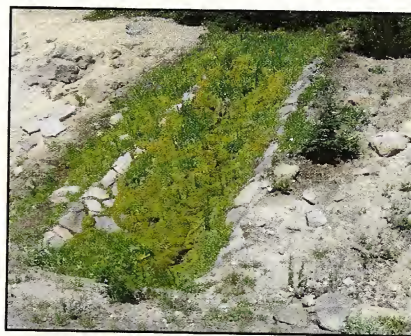
only slows water flow, but also increases the accumulation of rocks and debris that can clog the culverts they direct water into. Furthermore, the roots of weeds and shrubs growing through deteriorated mortar can damage the stones and open pathways for moisture to penetrate.<sup>20</sup> Mosses and lichens also retain moisture that erode stone and mortar.

Moss covered spillway at mile 5.0.

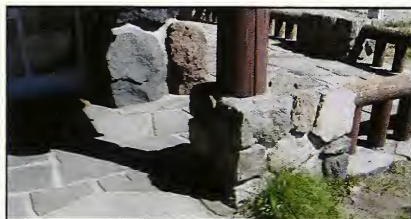
Front patio of the Steel Center at Park Headquarters.

Repointing the mortar of tiled features should be done with consideration to stone size, shape, color, and texture of each individual feature as they vary widely according to function throughout the park. Spillways, drains, and tree wells were built with much smaller stones and tighter joints than features such as the walkway at the Superintendent's Residence and the patio in front of the Steel Visitor Center.

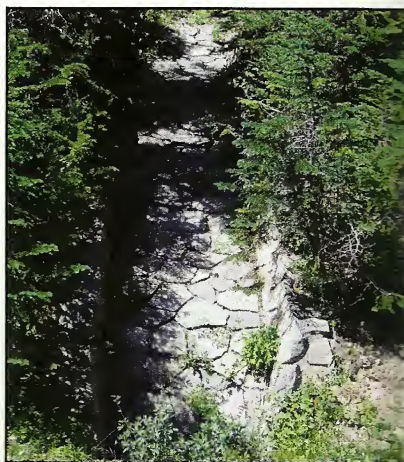
When replacing stones while repointing care should be taken to firmly press the stones back into place to eliminate air pockets in the mortar. Air pockets create voids where the stone is unsupported and can lead to cracking when weight is applied. The proper width and depth of mortar joints should be determined according to the historic practice utilized for each individual feature. The following photograph shows an excellent example of a spillway that can be used as a reference for directing repair.

Tiled spillway at mile 3.5.

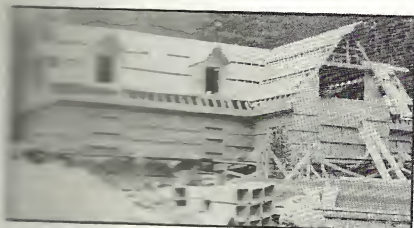
Buildings at Crater lake were constructed with large weathered stones and boulders set in place with cement mortar on the exterior and poured concrete walls between the masonry and interior timber form work. This construction method served several purposes but mainly it allowed for swift construction necessitated by short construction seasons, provided the structural strength necessary to support the use of very large boulders on the exterior, as well as a smooth wall surface on the interior.<sup>21</sup>

Construction of the Superintendent's Residence showing application of the exterior layer of masonry (Photo: National Park Service).

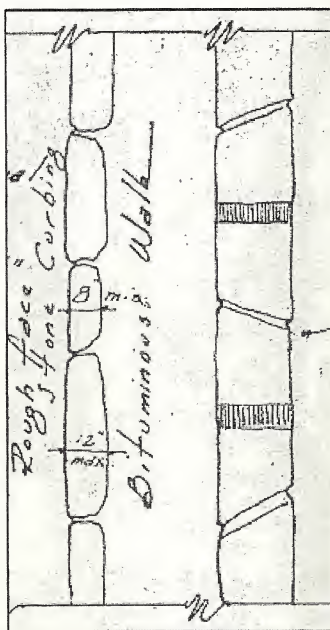
Note that the drawings call for approximately 8 inches of exposed curbing and that stones range from 8 inches to 12 inches in width across the top. The top and upper 10 to 12 inches of stones were dressed and trimmed by hand before setting them into place. The joints between stones should be between 1 and 2 inches wide.<sup>23</sup>

Plan view of guard wall and curbing at Kerr Notch (Detail from drawing by Francis G. Lange).

Both the curbing and the guard wall at Kerr Notch are excellent examples of original work and should be used as a basis for comparison when repair work or new construction of either curbing or guard walls is undertaken.

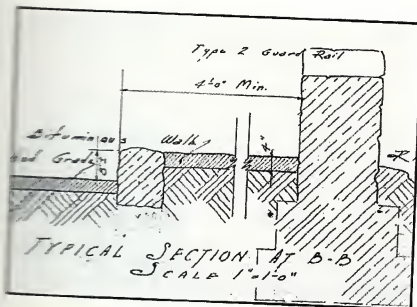
Cross-section of guard wall and curbing at Kerr Notch  
(Detail from drawing by Francis G. Lange).

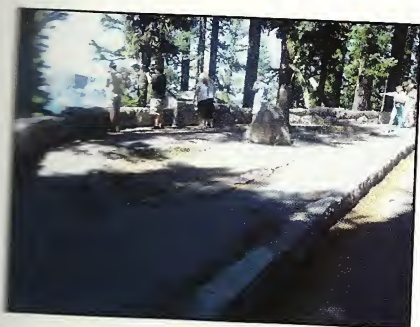
Kerr Notch Observation Station at mile 8.5.

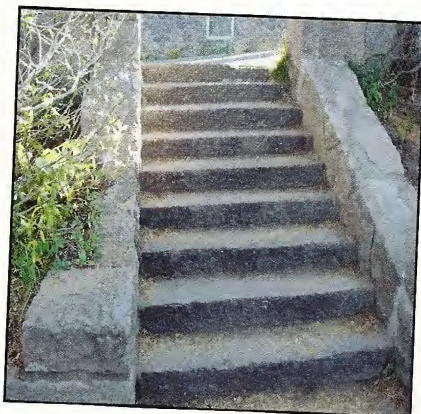
Historic stone steps at the Lodge Bay at Rim Village.

The historic steps are constructed using large rectangular stones rather than several small stones. In some cases, such as at the Lodge Bay, each step is a single slab, whereas the newer steps leading up to the café and gift shop from the parking area at Rim Village are much smaller and have a layer of flagstone pavers on top of each tread. Ideally, any new steps constructed at Crater Lake should be designed using historic examples as prototypes.

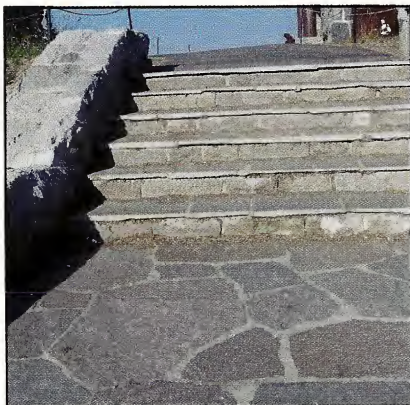
Newer steps leading from the parking lot to the café and gift shop at Rim Village.

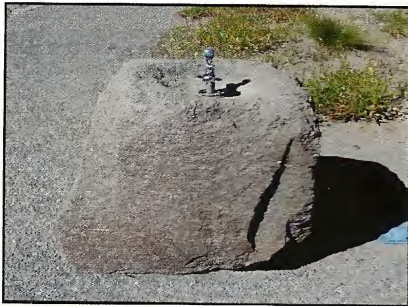
Drinking Fountain at Park Headquarters.

Historic stone drinking fountains are found at Rim Village, Kerr Notch, and Park Headquarters. They were designed with a rustic theme and are important to the historic character of the park.

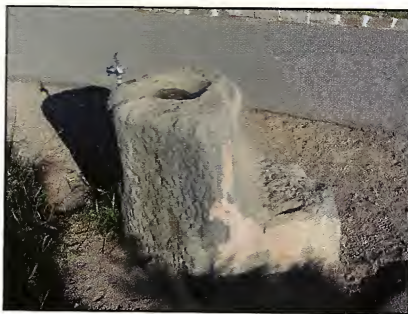
Drinking Fountain at Rim Village.

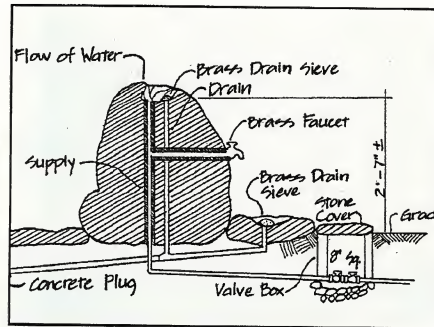
The following drawing illustrates the construction plan for drinking fountains and should be referenced for any maintenance concerns.

Section drawing of drinking fountain (*Drawing: Gilbert and Luxenberg, p. 103*).

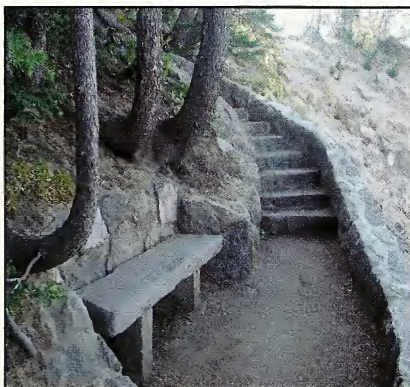
One of the two stone benches in the bay below the lodge along the promenade at Rim Village.

are found in the park. Two stone benches are located in the circular bay along the promenade below the lodge at Rim Village, as well as on the Watchman Trail and the Garfield Peak Trail. It should be noted that bench designs of those found on the trails are much simpler in comparison to those found in the Lodge Bay. The aesthetic quality of all benches should be maintained if they are damaged. New stones should be selected in accordance with size, texture, scale, and color of the originals.

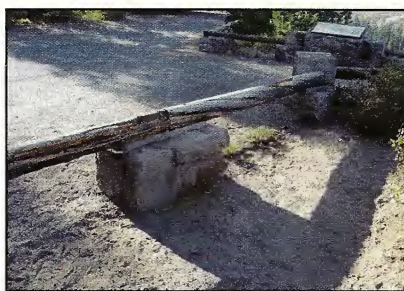
Stone masonry pier and log guard rail at the Pinnacles Overlook.

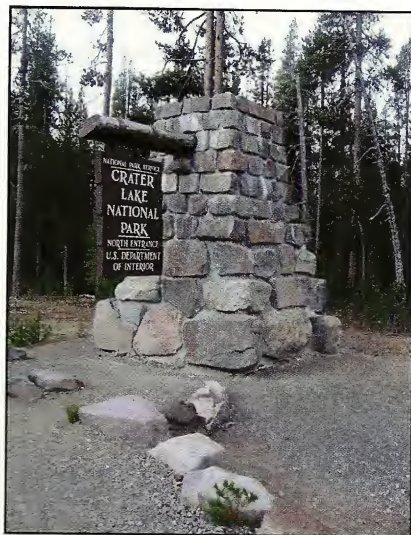
North Entrance Sign to the park showing wood and stone construction.

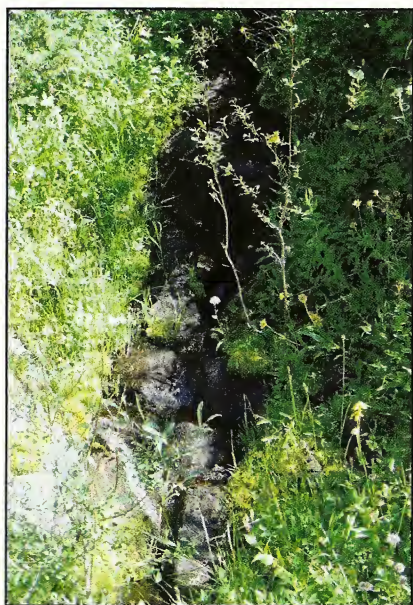
Dry-laid spillway at mile 1.0 on left side of the road.

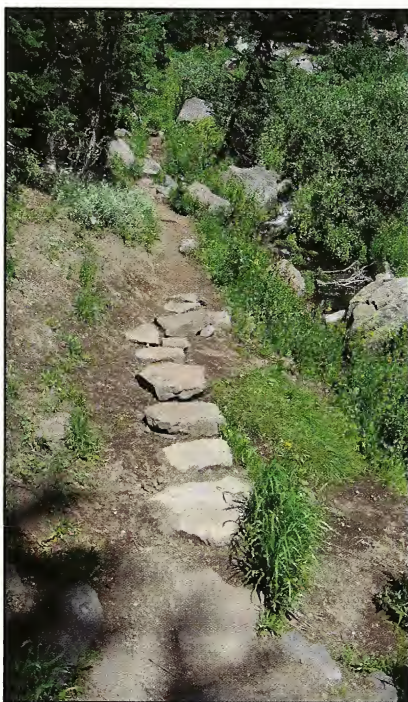
Stone lined section of path on the Castle Crest Wildflower Trail.

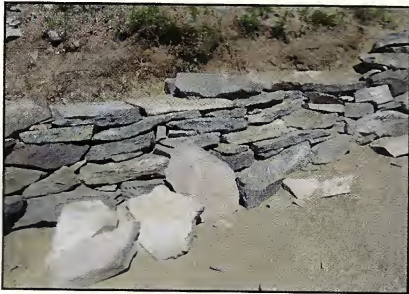
When repairing dry-laid retaining walls, it is important to maintain the appropriate batter angle used to erect the wall. This angle was originally determined by the height of the wall. If this was done correctly then slight movements in the ground will further secure the structure in place. It is this property that permits a dry-laid wall to be constructed without a concrete footing for extra stability.<sup>26</sup>

Retaining wall at Discovery Point Observation Station at mile 28.7.

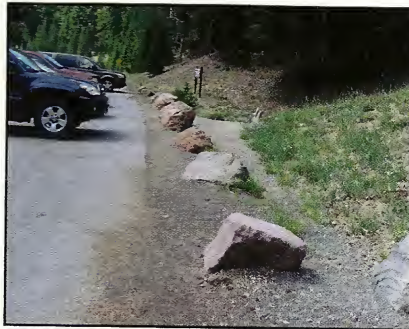
Boulders used to outline the parking area at Sun Notch.

One other "method" of dry-laid construction that is found in several locations throughout the park is the use of boulders to define parking areas and provide barriers for vehicular traffic.

This practice should be stopped in favor of the historic practice, originally devised by Francis Lange, one

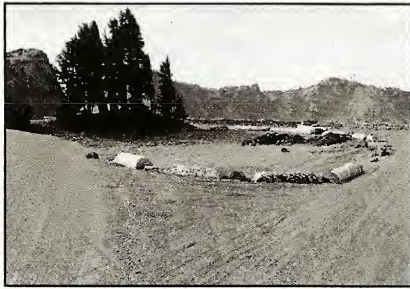
of the early park landscape architects, of alternating boulders and logs. As demonstrated in the historic photograph below, the boulders and logs were partially buried and the logs were treated and their ends chamfered.

Historic photograph showing Lange's log and boulder treatment (Photo: National Park Service).

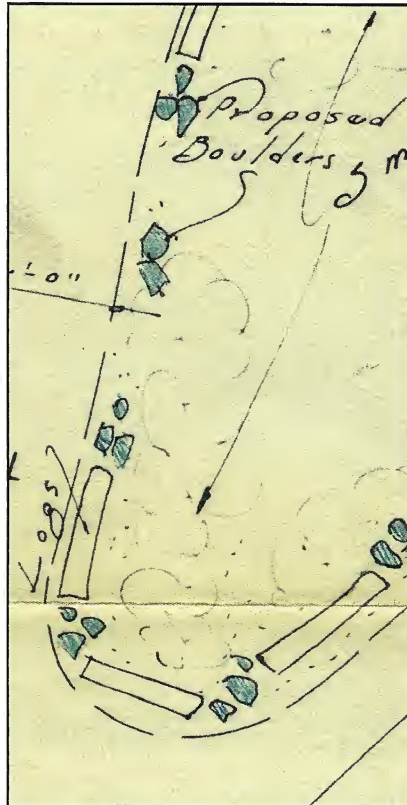
Drawing of Francis Lange's log and boulder barrier (Drawing: National Park Service).

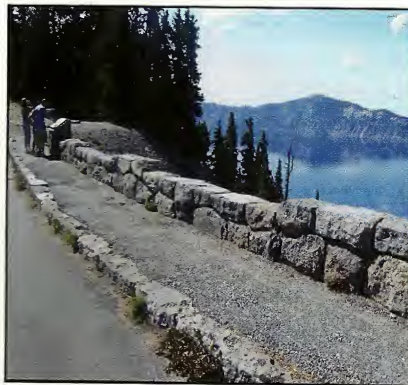
Guard wall at Pumice Castle Overlook at mile 11.0 showing proper variation in stone size, shape, and color.

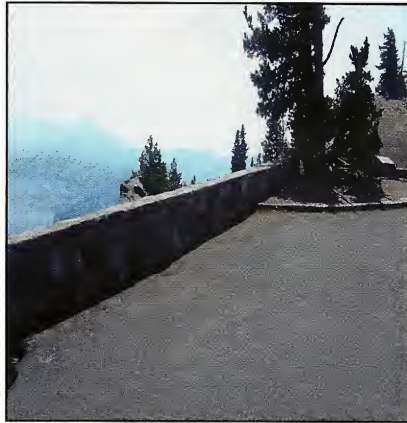
The guard wall at the turnout at mile 24.0 was constructed without merlons at regularly spaced intervals even though the view behind the wall is unobstructed.

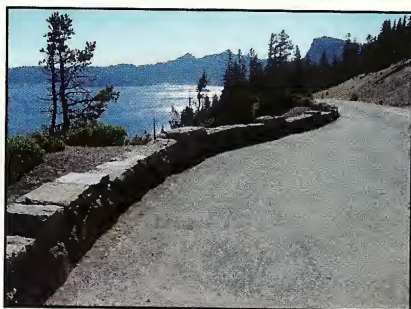
The curvilinear form of this guard wall at the turnout at mile 18.9 follows the natural shape of the rim but also retreats back to provide different views of the lake.

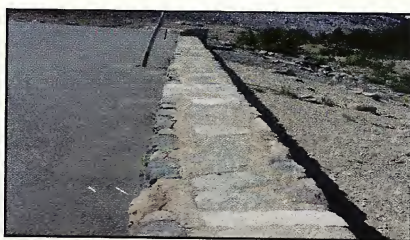
The guard wall at the turnout at mile 25.2 forms a rigid, straight line that contrasts with the surrounding terrain. Also notice that the mortar joint were not raked and the stones are not of the specified size.

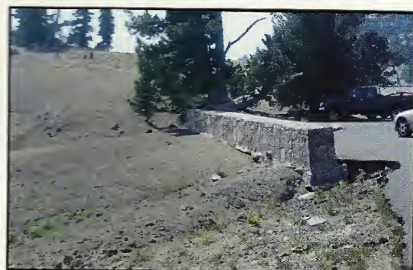
This wall demonstrates incompatible stone work with the use of shaped stones with cut faces exposed. The absence of rough-faced stones and the bunching of small, more uniformly sized stones creates an unnatural appearance.

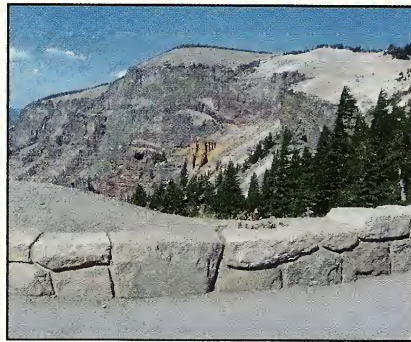
Joints are raked back to the specified depth of  $\frac{1}{2}$  inch so the stones are recognizable as individual units and have a more natural appearance, similar to that of a rugged cliff.

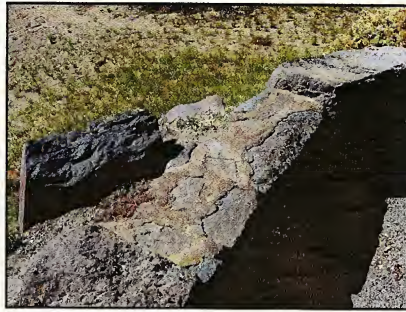
This wall section shows incompatible mortar application. The joints are not raked back allowing the mortar to become more significant than the stones.

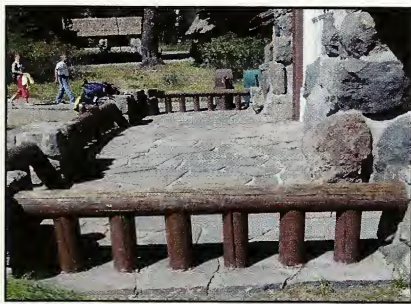
The stone patio outside of the Steel Visitor Center is another example of proper mortar application and joint raking.

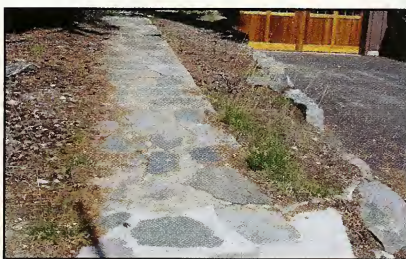
The stone walkway at the Superintendent's Residence (Science and Learning Center) demonstrates inappropriate mortar application and joints that are not properly raked.

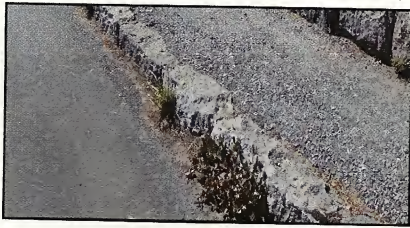
Curbing is constructed using dressed stone of appropriate size and shape.

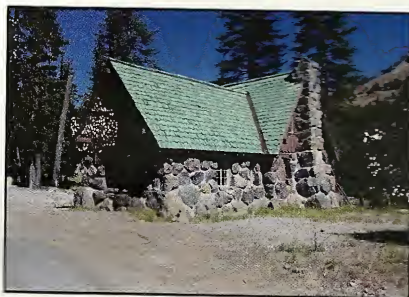
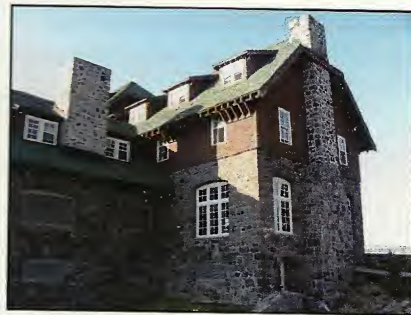
Maintaining the type of stone and detailing within a structure is of utmost importance to retaining historic character. The photo on the left is the historic Chief Naturalist's Residence and the photo on the right is the Crater Lake Lodge. Both are examples of rustic architecture but variation in stone size should be noted. The Naturalist's Residence was constructed with large stones at the base and progressively smaller stones in the upper portions of the walls whereas the lodge was constructed with much less variation in stone size. Be aware of these aesthetics and replicate them as necessary. A significant difference can be seen in the stone selection and mortar application of the two chimneys on the lodge that contrasts sharply with the rest of the building.

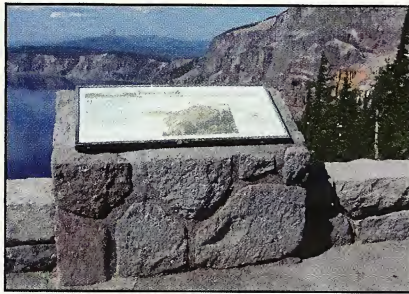
Compatible monument addition to the guard wall at the Pumice Castle Overlook.

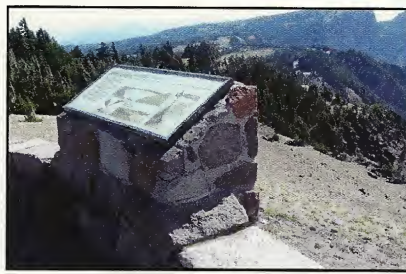
Addition of the monument to the top of the merlon was done using stones of incompatible size and color.

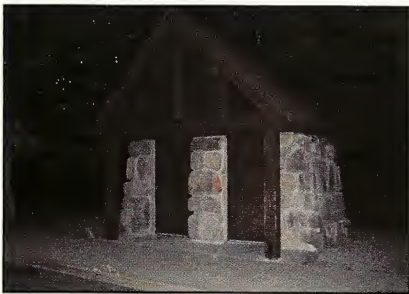
Although this vault toilet was constructed with concrete faced in stone, it demonstrates compatible new construction as it has many of the same characteristics of original work throughout the park including raked joints and proper variation in stone size, color, and shape.

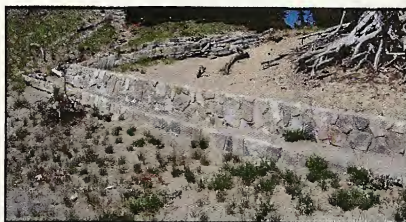
The guard wall constructed at the Discovery Point Observation Station is incompatible with historic guard walls throughout the park. Although the stone sizes and colors have appropriate variation, they lack the rustication of those used in the historic walls. Furthermore, the joints are not raked deep enough to expose the mass of the stones.

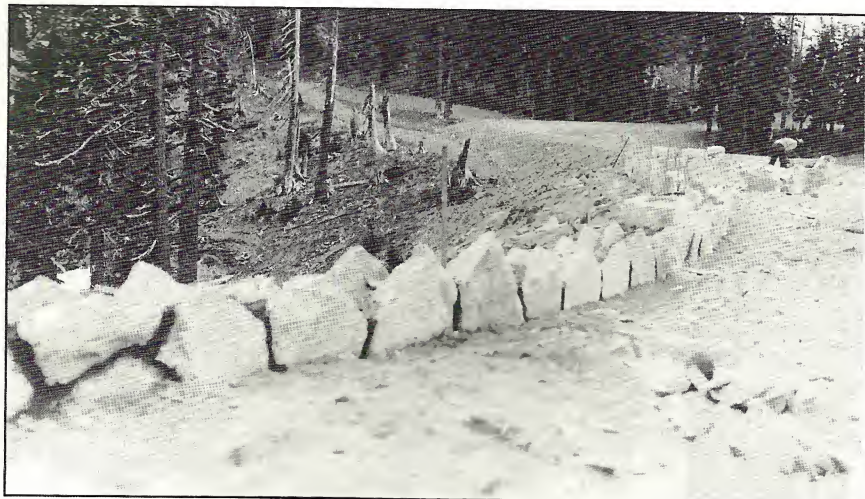
Historic photograph of the construction of a stone masonry guard wall near Pumice Point, 1934 (Photo: National Park Service)

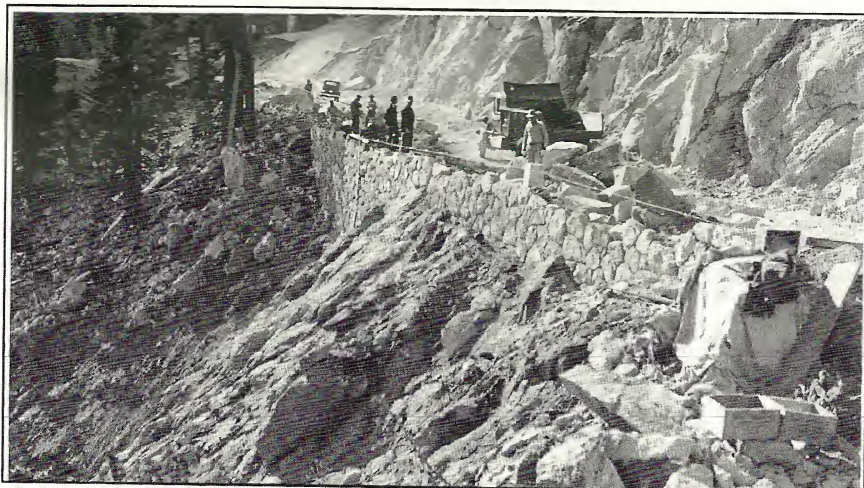
Historic photograph of stonemasons building a retaining wall at Scott Bluffs, 1934 (Photo: National Park Service)

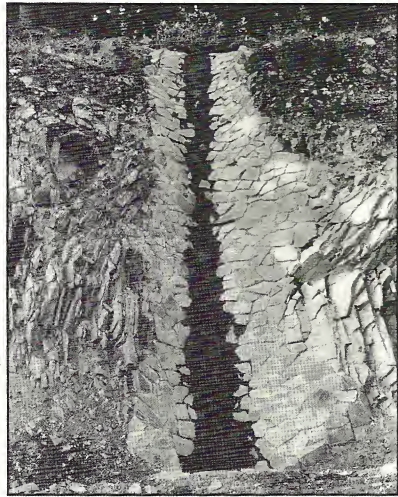
Historic photograph of a tiled stone masonry spillway along Rim Drive (Photo: National Park Service)
